ERA24FA058

## INVESTIGATION PHOTOGRAPHS

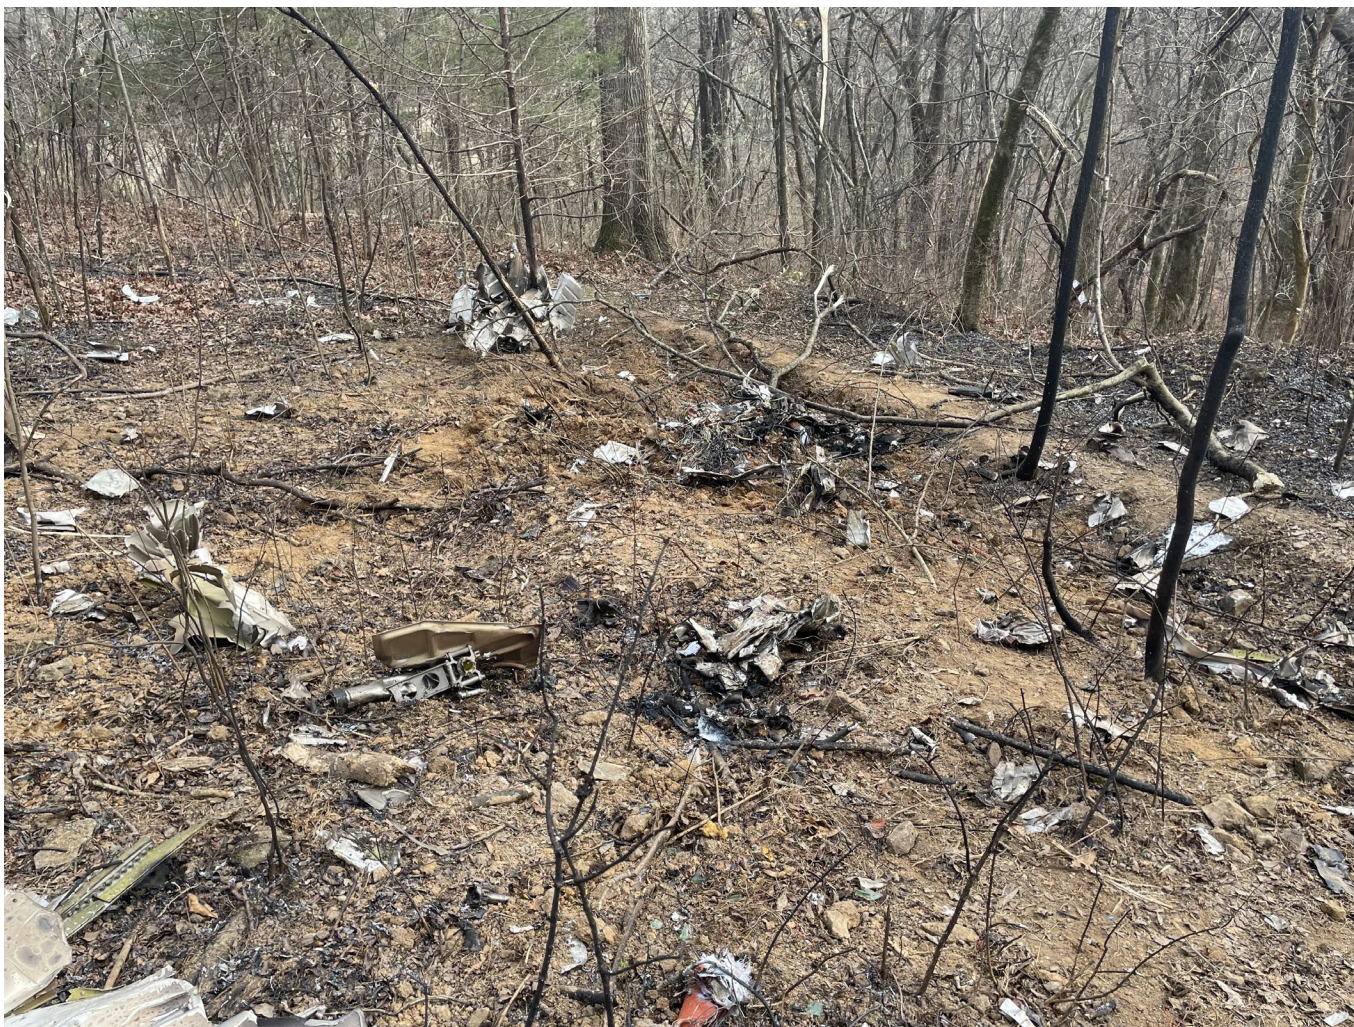
**Photograph 1 - View of main impact site. The airplane approached from right to left in the photograph.**

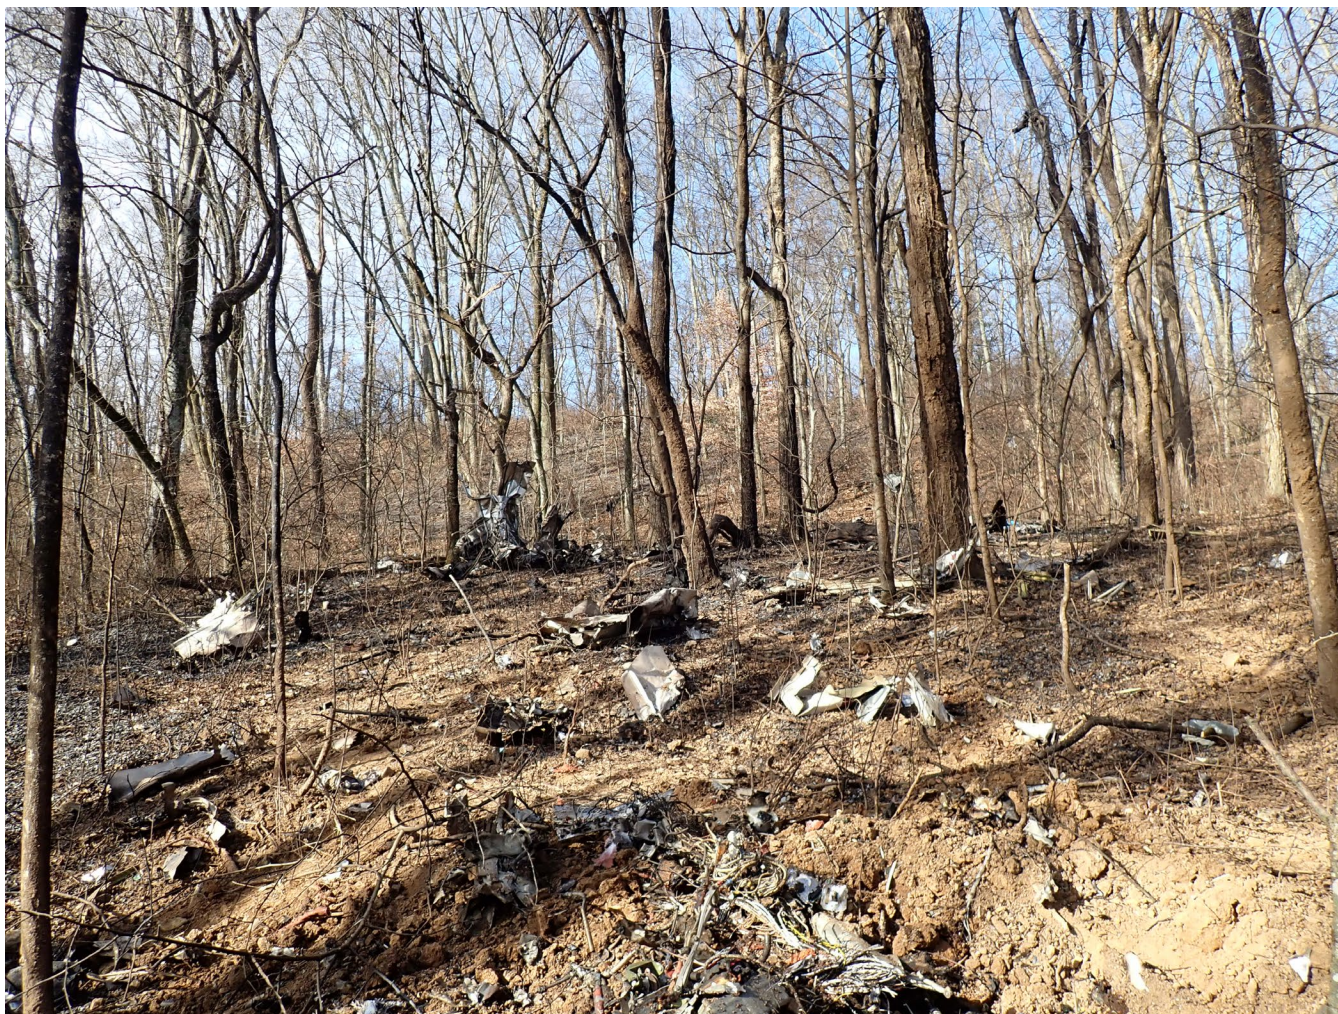
**Photograph 2 - View of debris field taken from main impact site looking up the hill at the debris field.**

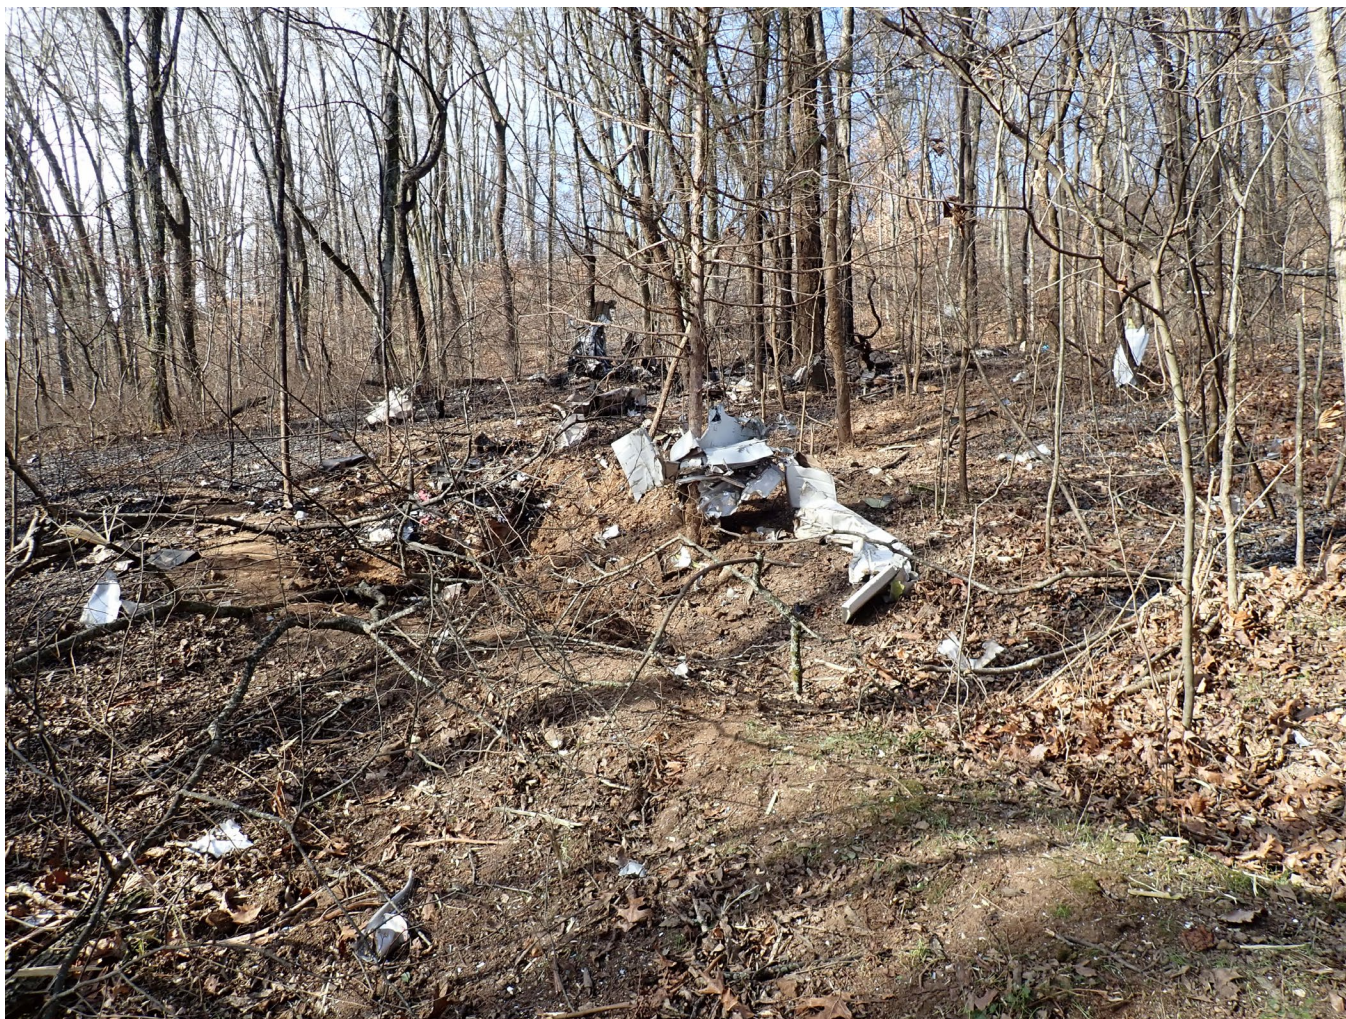
**Photograph 3 - View of main impact site and wreckage debris field.**

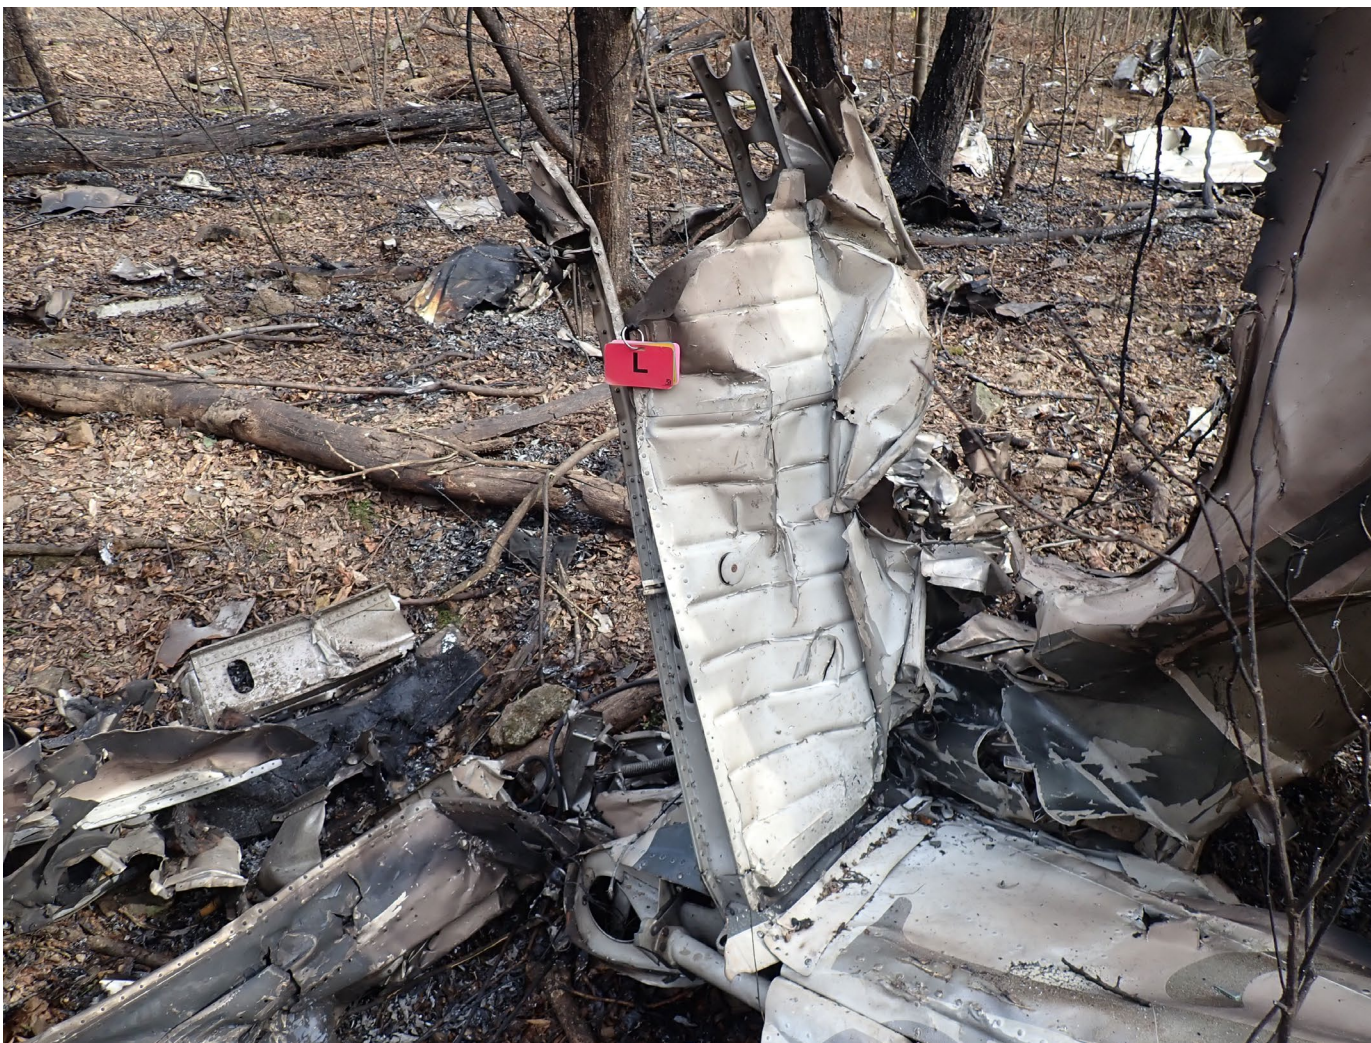
**Photograph 4 - View of left elevator and vertical stabilizer.**

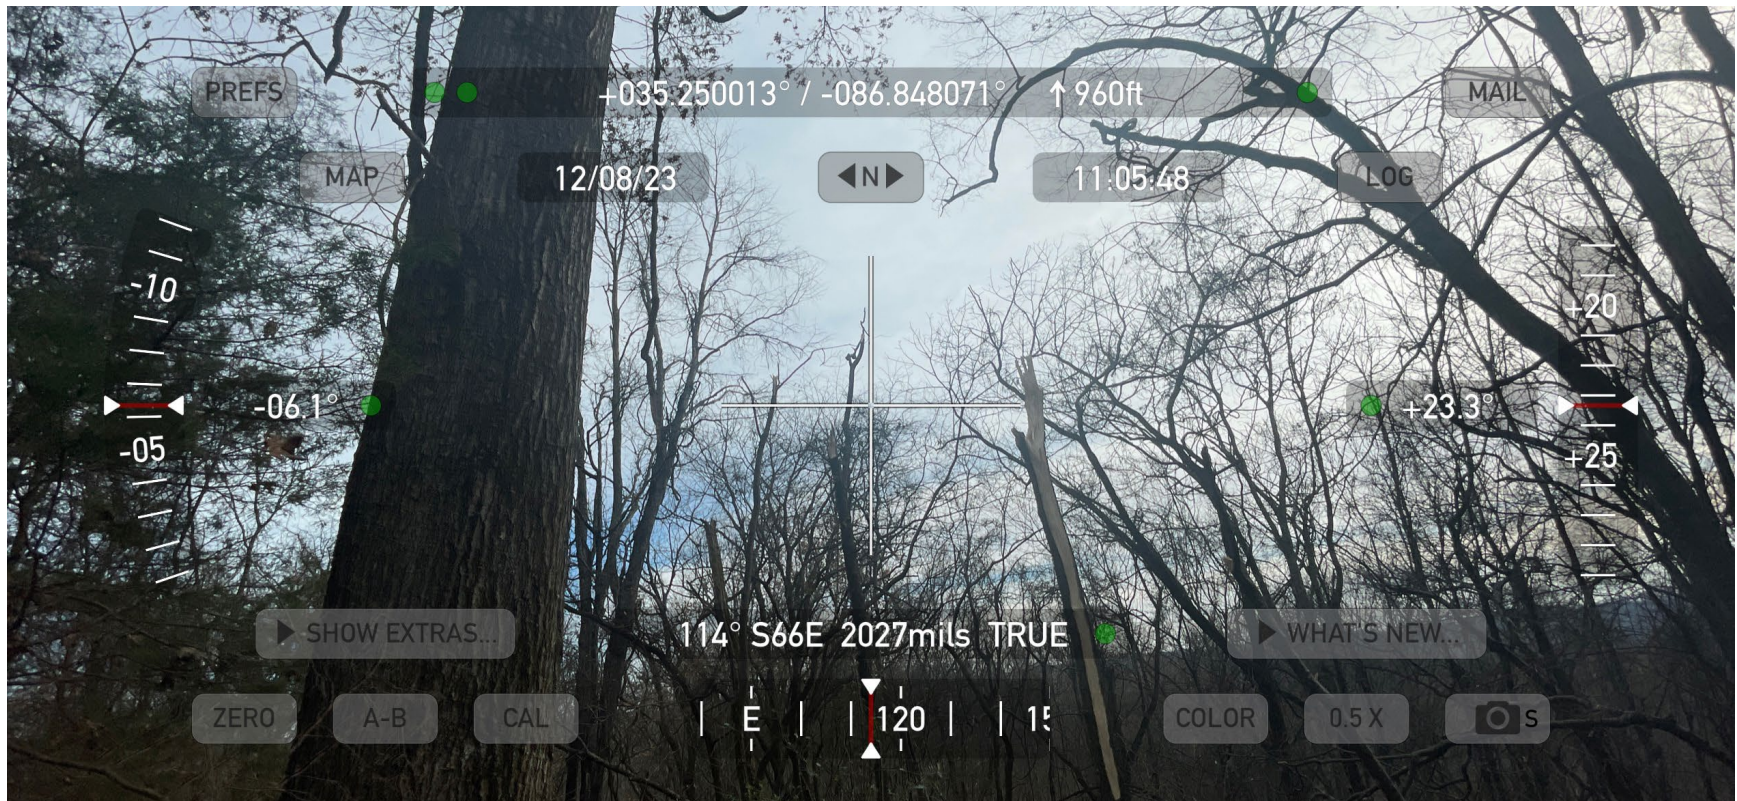
**Photograph 5 - View of approximate direction of travel taken from main impact site.**

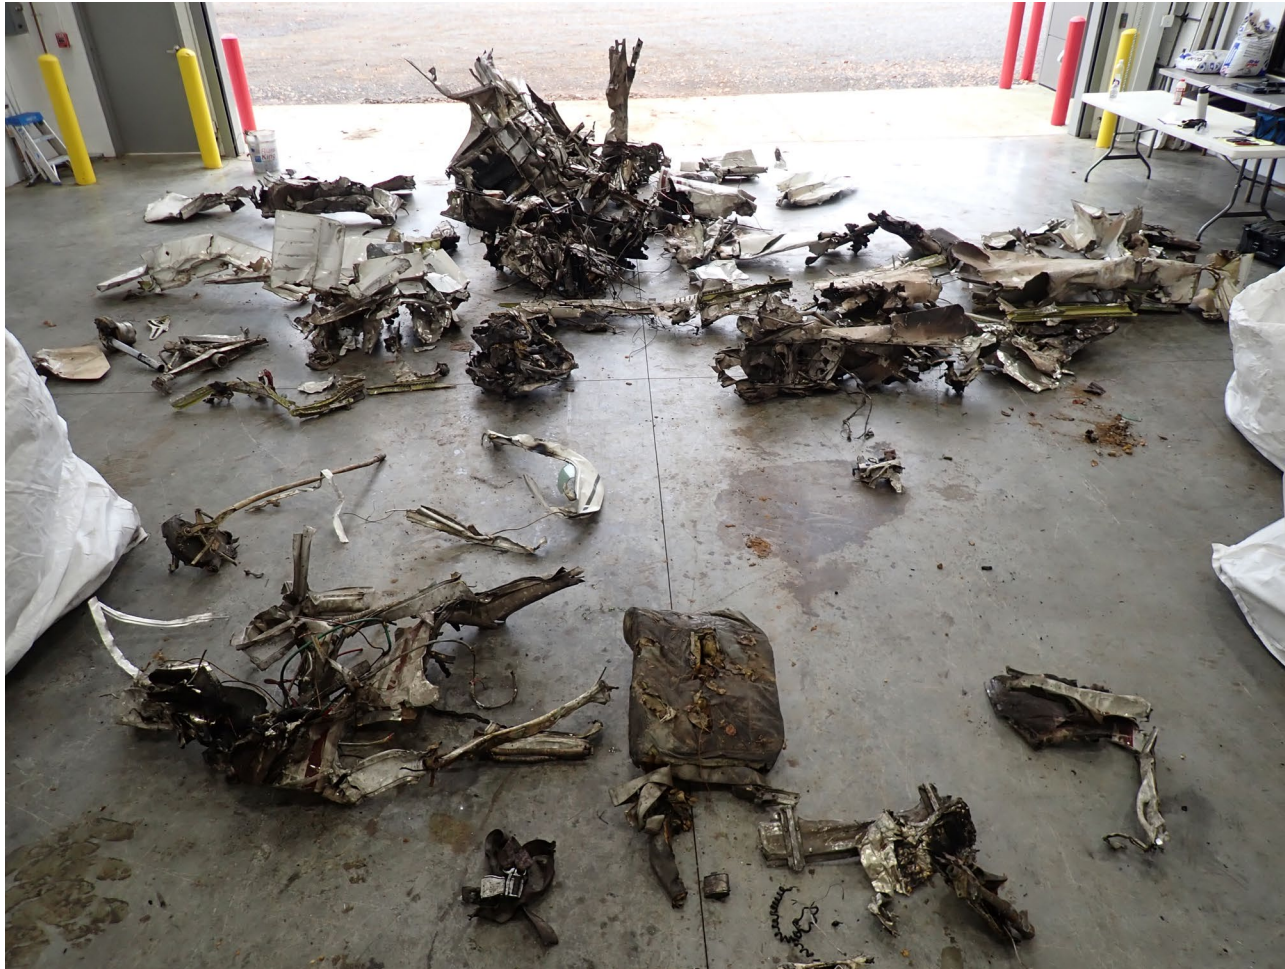
**Photograph 6 - Hangar floor layout of wreckage looking aft.**

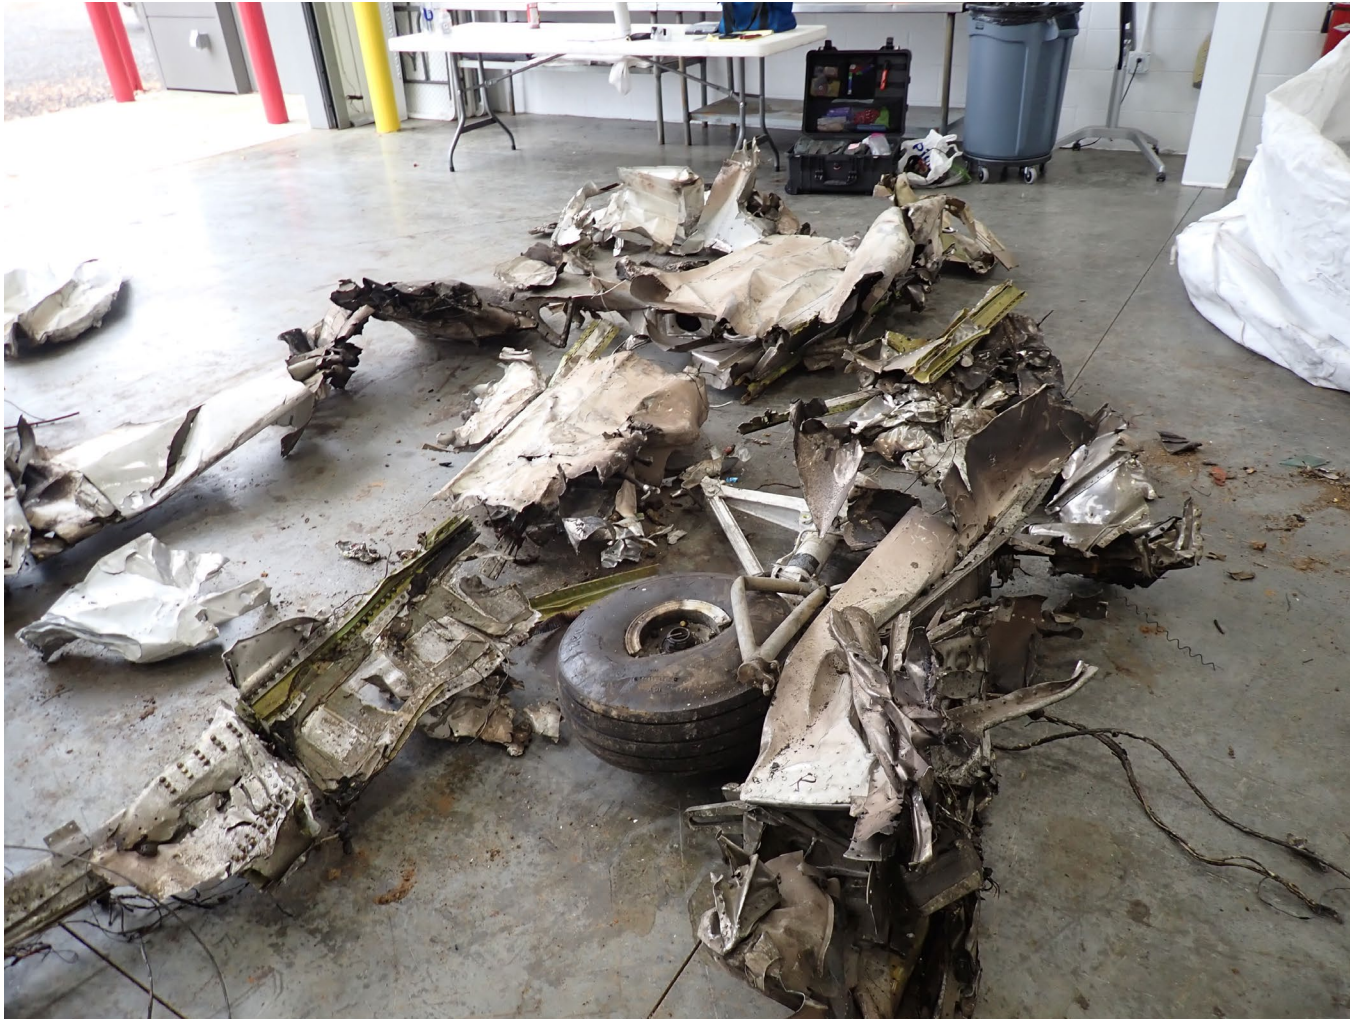
**Photograph 7 - View of left wing and landing gear during hangar floor layout.**

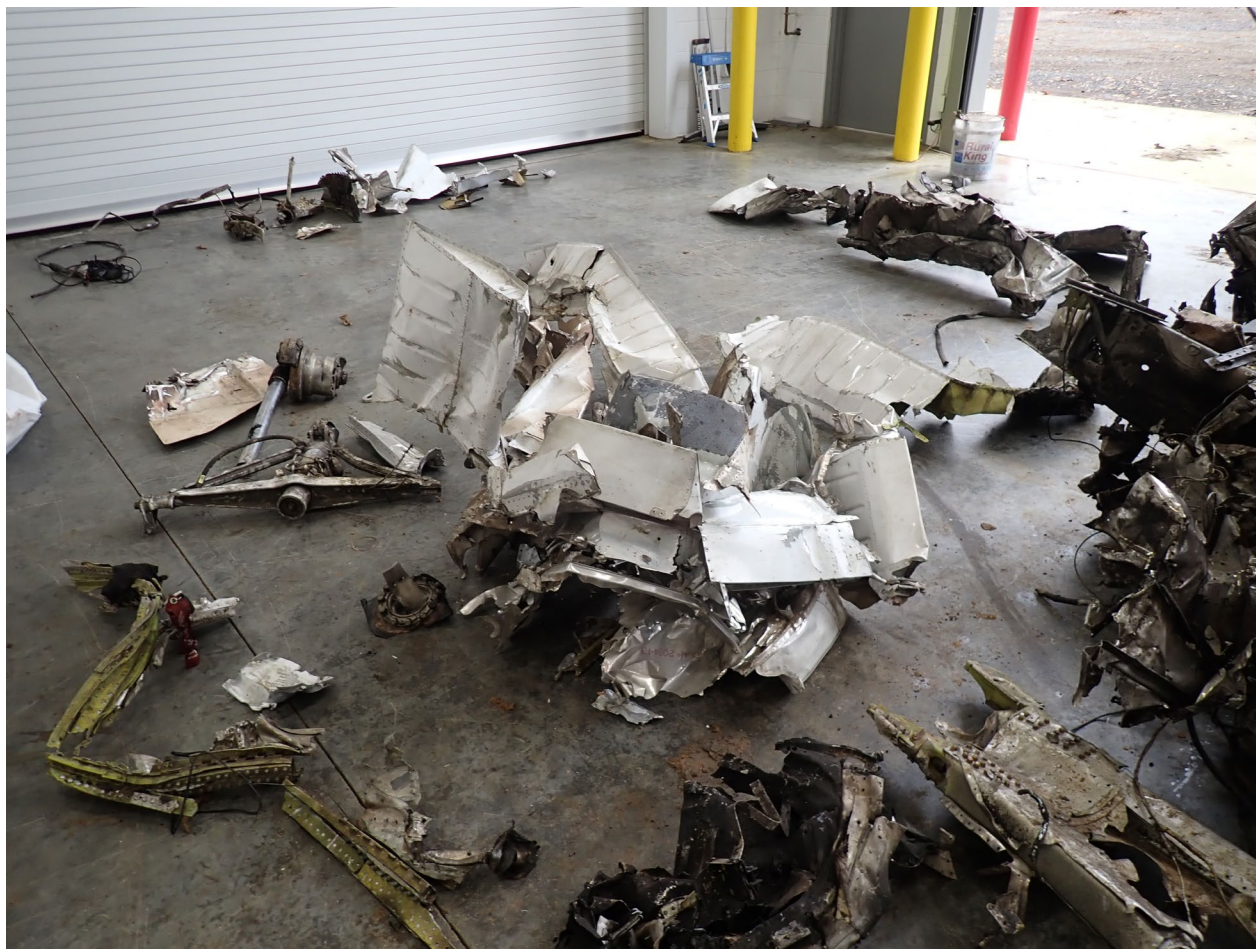
**Photograph 8 - View of right wing during hangar floor layout.**
